# TN – TP MAGNA CLUTCH CONCERNS

This bulletin outlines common faults experienced after fitment of a new clutch in these vehicles and to help avoid experiencing these issues.

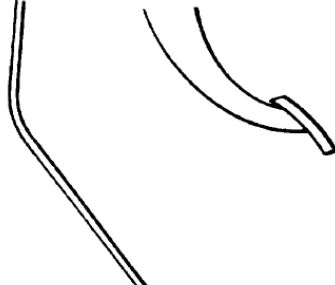
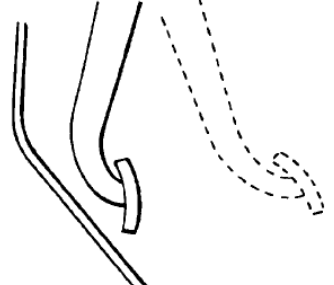
- The clutch master cylinder push rod has been adjusted previously to give the clutch release bearing more travel. Incorrect adjustment can result in negating the self-adjusting mechanism and/or over-stroking of the diaphragm which will foul the clutch plate making gear selection difficult. It is important to ensure the clutch pedal adjustment is kept to the specifications below.

<p>Pedal Play: 6-13mm</p>	<p>Clutch Engaged: 173-178mm</p>	<p>Clutch Disengaged: 55mm+</p>
