NAVARA D40 DISENGAGING 5TH GEAR

Nissan Navara D40 2.5L YD25DDTI 2005-

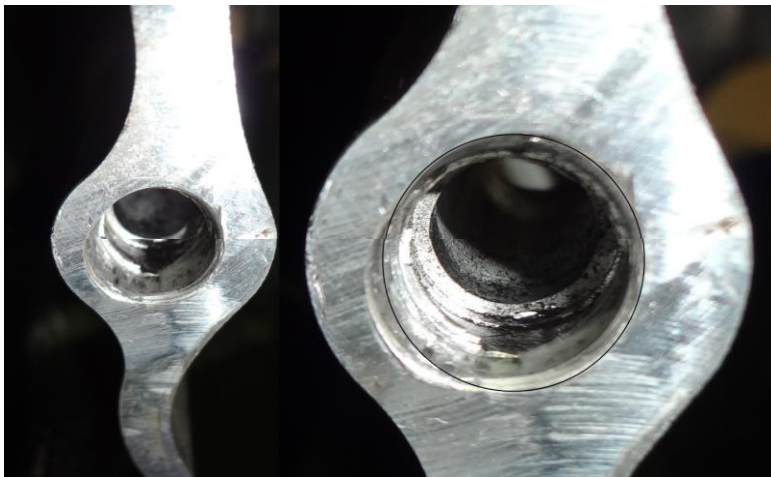
If this condition occurs the most common cause is due to gearbox misalignment. Often due to the weight of the transfer case. This misalignment can cause the input shaft and clutch plate assembly to induce a harmonic that will see the 5th gear synchronizer sleeve move away from the gear set and shift out of 5th gear.

To check for this the gearbox will have to be removed. Inspection of the dowels and locating holes used to position the bell housing to the rear of the engine should show evidence of misalignment as per the image below.

If misalignment has occurred it is recommended that the dowels are replaced and damage to the locating holes cleaned up as best as possible.

Care must be taken to ensure that driveline alignment is correct at all times during installation and the bell housing bolts are tightened evenly.

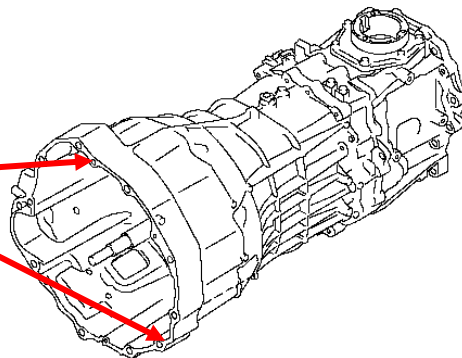
Dowel locations

(may vary by transmission)
