TOYOTA PRADO KDJ120 SERIES SHUDDER COMPLAINT

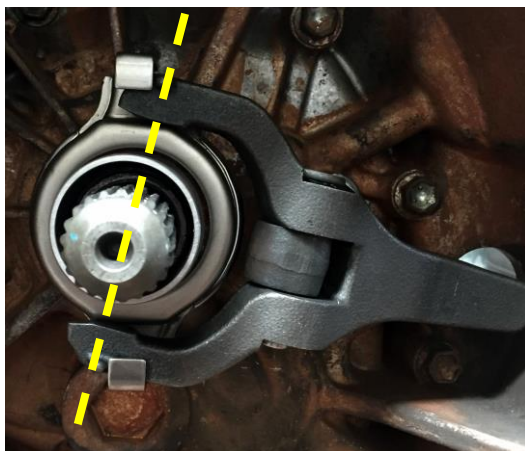
Although the fork is cast iron and the contact point between bearing carrier and fork need inspection for wear also, it has been found that the Clutch Fork Retaining Spring is the root cause of this complaint. This retaining spring is made from spring steel and needs to be replaced in conjunction with each clutch installation.

Please note that attempts to repair this spring clip are often unsuccessful which allows the fork to sit off centre as per image 1) below, replacing the retaining spring will allow the fork to sit in line with the bearing as per image 2)

Image 1) Incorrect Fork Location

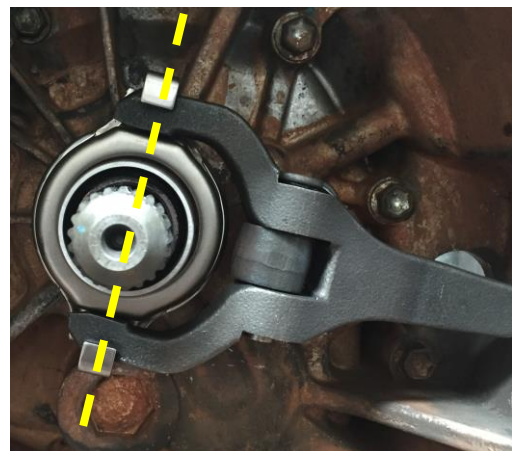
Image 2) Correct Fork Location

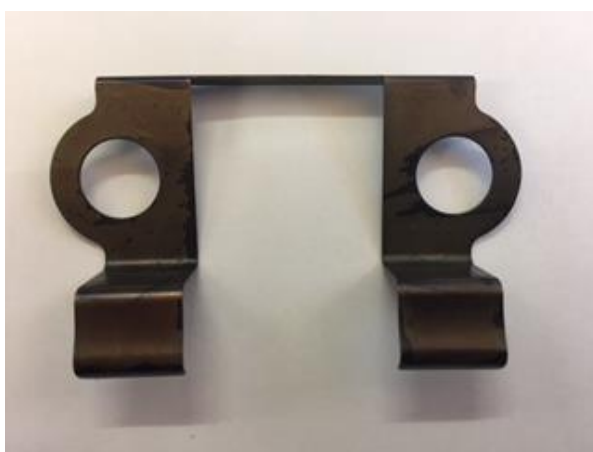
Image 3) Fork Retaining Spring

THIS POWERDRIVE CLUTCH KIT COMES WITH THIS SPRING AS A COMPLIMENTARY ITEM AND MUST BE FITTED TO AVOID ANY WARRANTY DISPUTES FOR THIS APPLICATION

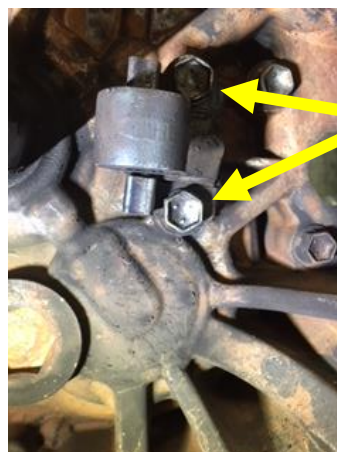
Image 4) Location of Fork Retaining Spring

The spring is located by two bolts, these will need to be re used for the replacement spring

Please Note:
Torque setting of the bolts is 26 Nm
