TOYOTA BEARING NOISE

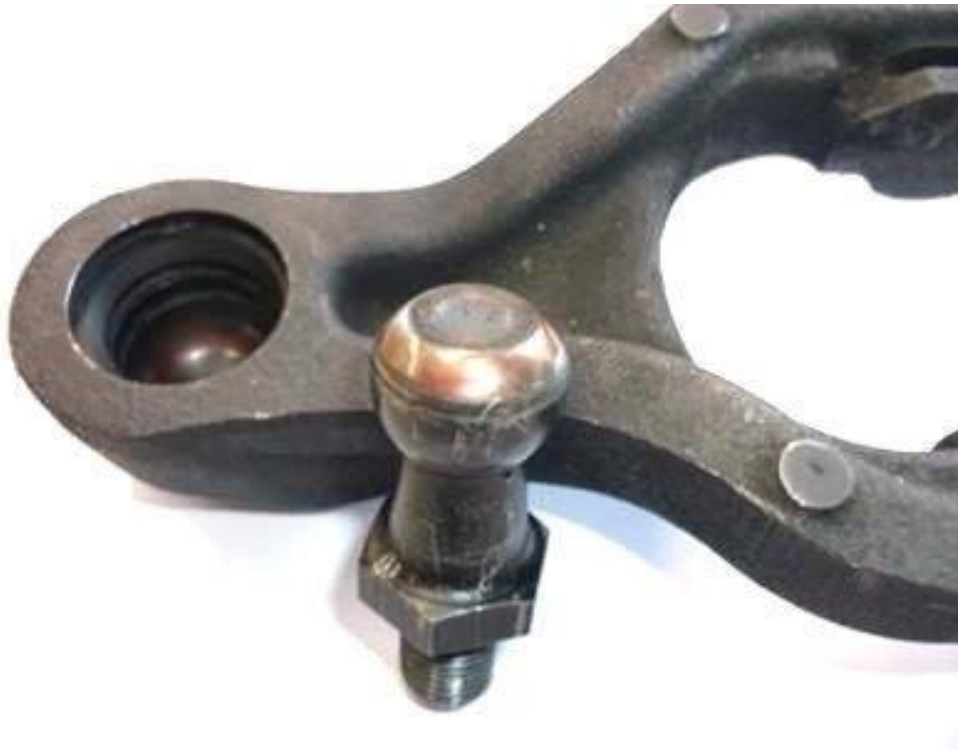
Incorrect diagnosis of faulty release bearings have become prevalent in these applications. The true cause of this issue is related to wear in the release fork and pivot ball.

This wear displaces the grease between the two mating surfaces and will create a noise that resembles bearing noise.

Please ensure that these parts have been inspected for wear and is highly recommended that both components be replaced.
