HOLDEN JACKAROO/RODEO CLUTCH RELEASE ISSUES

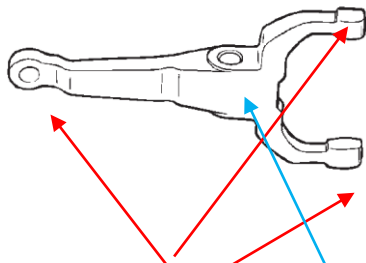
Release Fork & Bushings

Poor release and pedal feel is common in the pull-type clutches fitted to these vehicles. In most cases this can be attributed to the operating mechanism rather than the clutch itself. These issues are more prevalent in older and high mileage vehicles. Wear in any of these mechanisms can create an uneven or notchy pedal feel and restrict the clutch release.

If any wear is present in these areas it is recommended that they be replaced before the installation of the new clutch is performed.

!! THE CLUTCH FORK CAN BE FITTED BACK TO FRONT SO TAKE CARE IN RE ASSEMBLY !!
