SUBARU BEARING GUIDE SLEEVE REPAIR KIT

GSK001 / GSK002

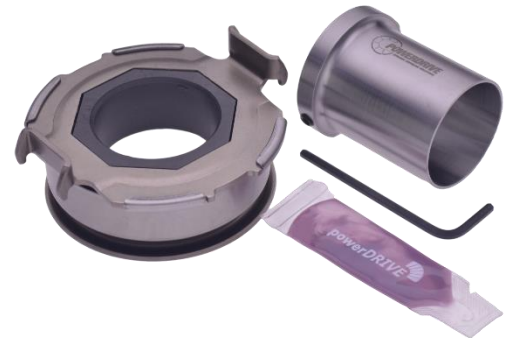
Over time, the release bearing can cause wear on the bearing guide of the transmission.

This can result in rough, notchy, sticking, or inconsistent clutch pedal feel.

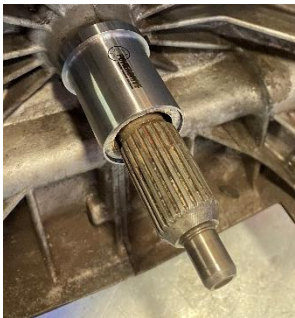
The POWERDRIVE Bearing Guide Sleeve Repair Kit has been developed to solve this problem, through the use of a hard-wearing stainless steel sleeve that slides over the original guide.

This sleeve is retained with a pair of set screws. The kit includes an oversized bearing to suit the increased sleeve diameter.
